- 9ng of pbar produced at fermilab

## Hit 9ng on St. Patrick's Day

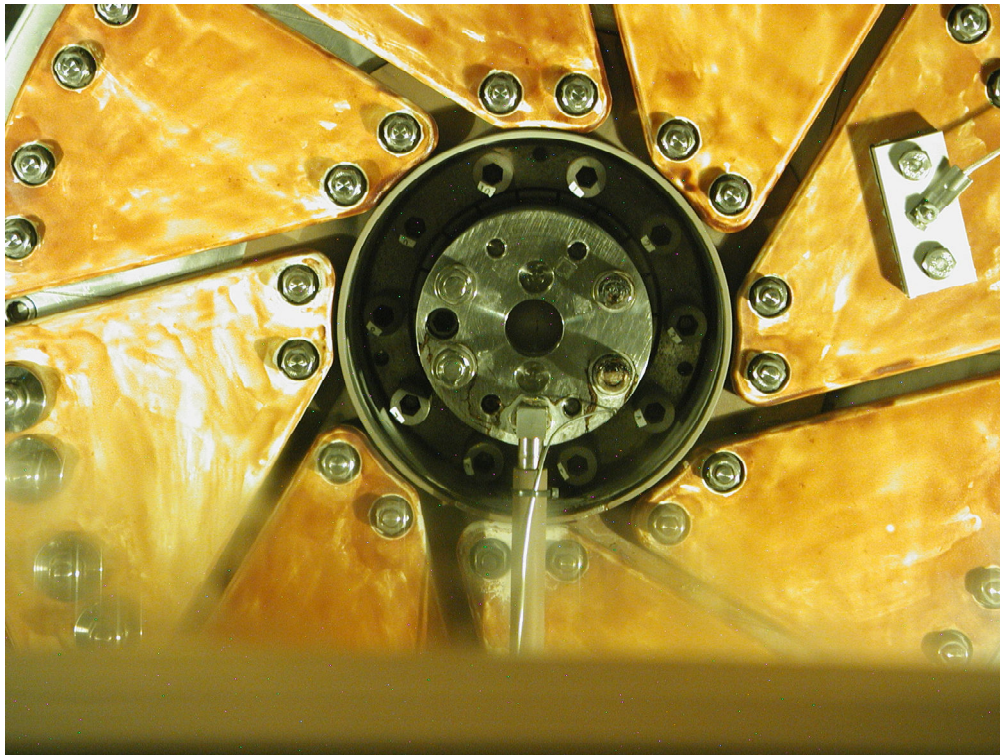
- 
- Evidence of water and Li hydroxide staining.
- VCR fitting - seal that presses against., seal should be held by tie rods.
- Tie rods suffering from creep. Lose elasticity over time. Then seal at vcr can start to leak.

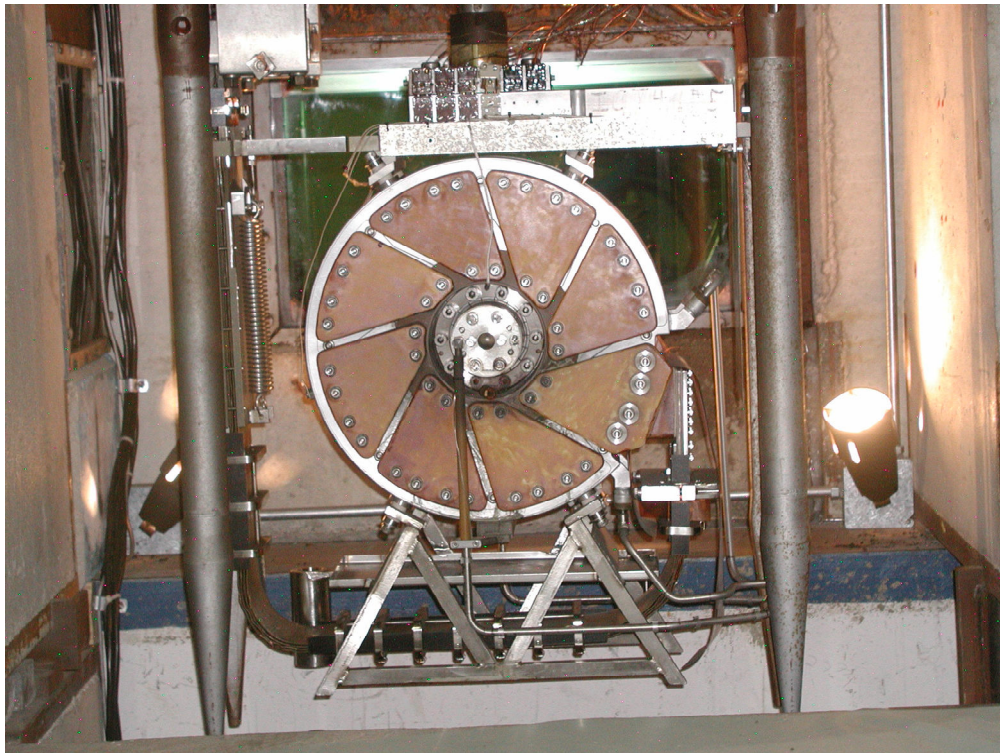
- Lens Status
  - Tie rod creep is possible cause of 10 mm-5 lens failure
  - Allows VCR seal pressure to be reduced resulting in water leak
  - Then lithium/water reaction can occur – investigating this
  - 10 mm-7 testing should be complete as early as Saturday by about 3/27
